PACKCHEK
Hot Melt Inspection for End-of-Line Packaging **FAQ's**

The PackChek System is the latest innovation in hot melt inspection for end-of-line packaging. Utilizing both thermal and visual imaging, PackChek inspects the heat signature of the package to ensure hot melt glue has been applied to the correct locations.

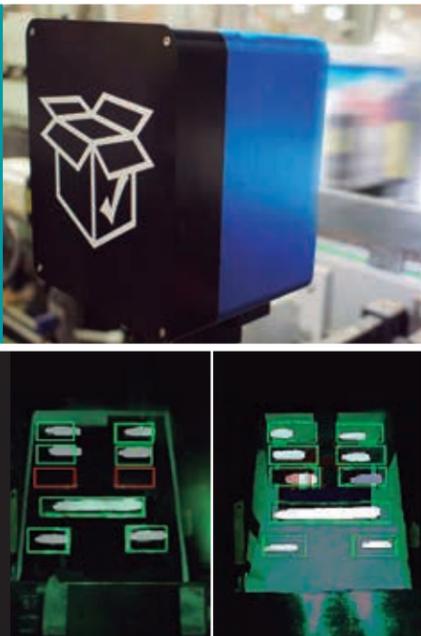
PackChek can be installed on virtually any line where hot melt is applied and, with the ability to use up to three cameras, it's ideal for case sealers, cartoners and even wrap around machines.

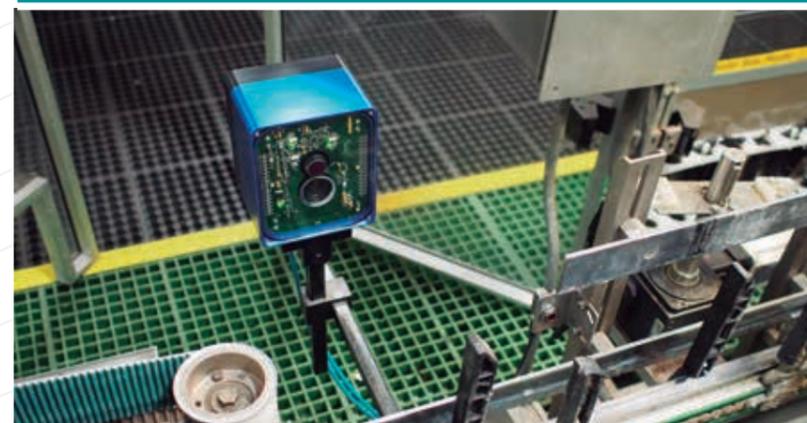
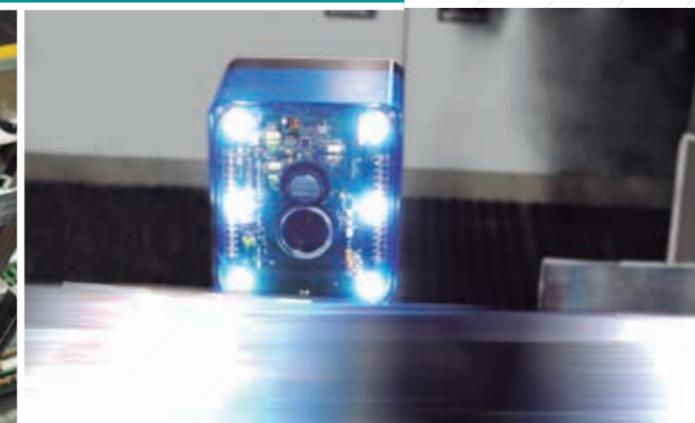
Valco Melton's PackChek system can be mounted either inside the packer, or on a discharge conveyor, which makes it easily adaptable to almost any packing line. Generally, installation is 1-2 days and requires an encoder signal from the area where the camera(s) is mounted (machine or conveyor), sensors at the gluing area, camera and discharge, and an ejector.
